# Tanyard Branch Watershed Management Plan

Performed for the Town of Easton, Maryland

*Prepared by Midshore Riverkeeper Conservancy and  
Center for Environment and Society at Washington College  
with photos by Aloft Aerial Photography*

January 11, 2013

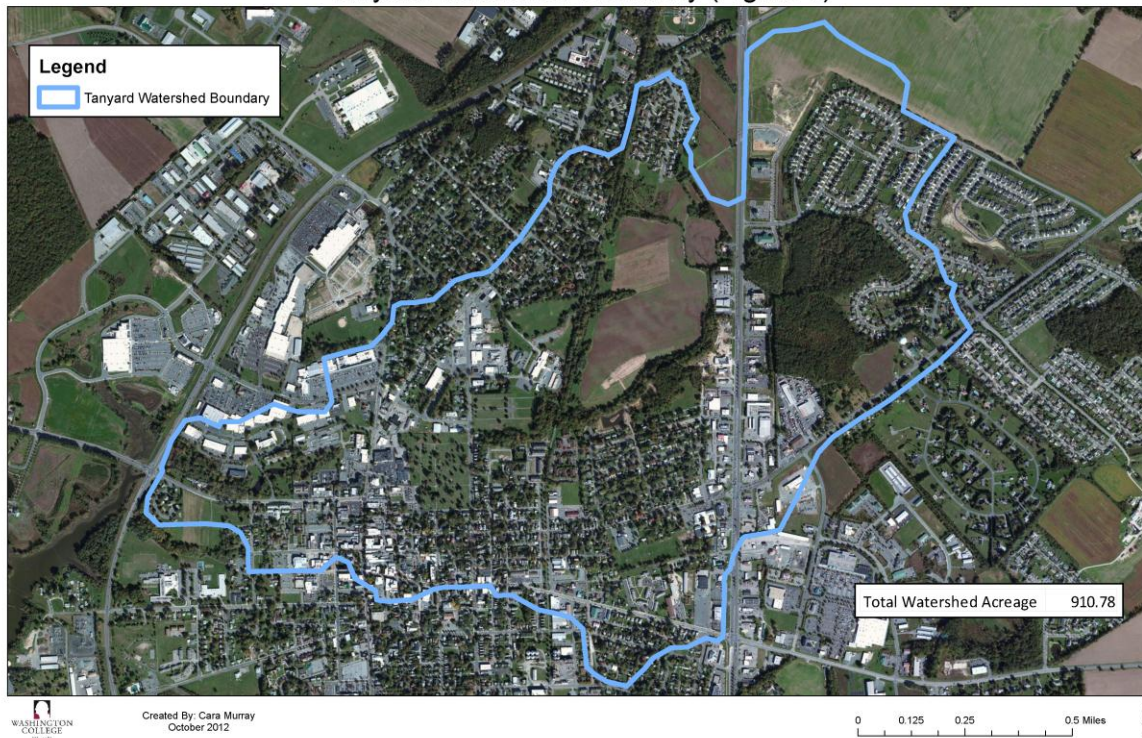
Figure 1: Overview of Tanyard Branch Watershed

Tanyard Watershed Boundary (Figure 1)

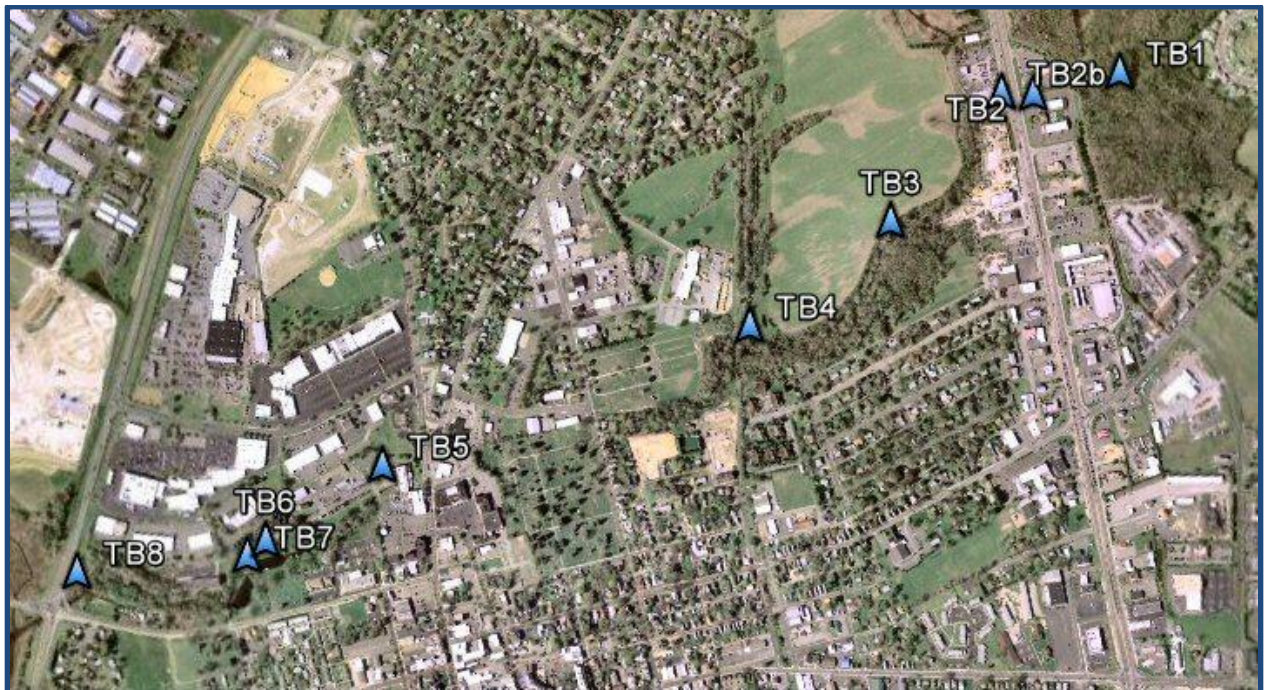
Figure 3. Sampling locations along Tanyard Branch.

Project staff conducted water quality sampling to gain a better understanding of the location of pollution loads and to assess restoration potential. Mr. Drew Koslow, Choptank Riverkeeper, and Dr. Christian Kraffhorst, Washington College, Center for Environment & Society, were responsible for the field efforts. Our sampling sites are numbered beginning upstream to downstream as depicted in Figure 3 below with exact GPS locations listed in Table 1.

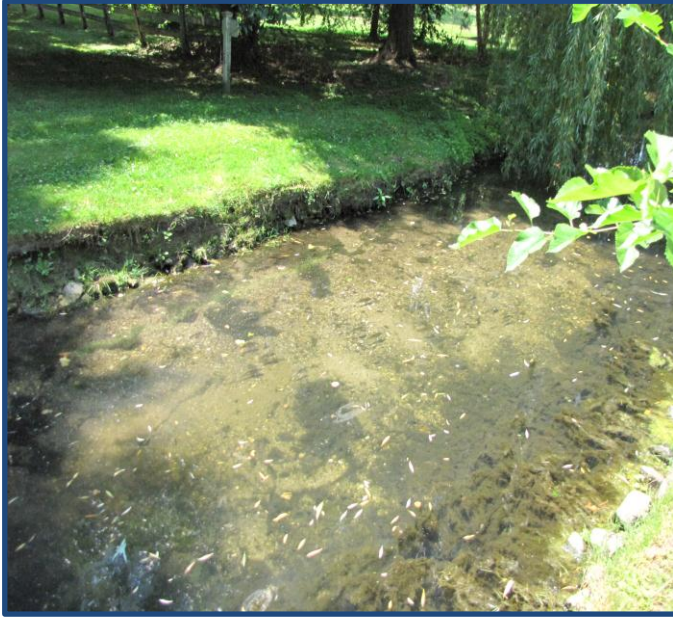
**Photo 1:** Tanyard Branch just downstream from TB5, July, 2012. Large algal mats covered the whole reach between TB5 into the upper Bay Street Pond.

**Figure 4.** Photos of algae growth within the Tanyard Branch.

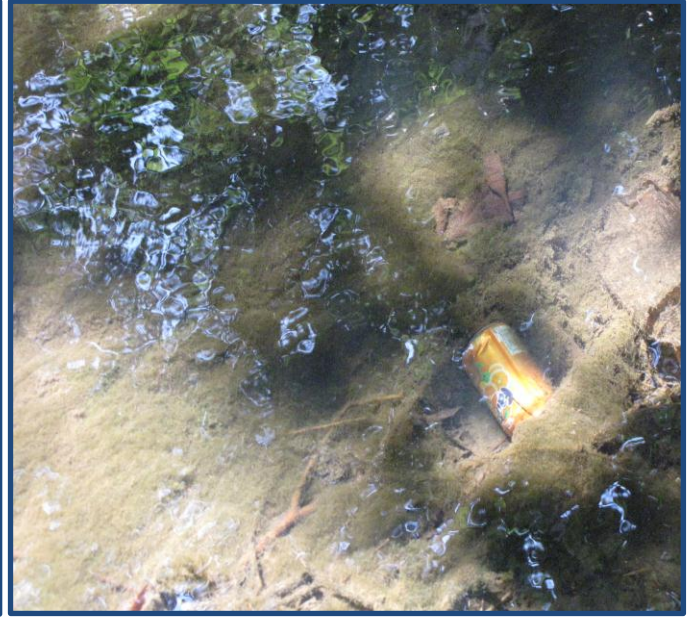
**Photo 2:** Tanyard Branch at TB3, October 2012. Heavy growth of algae covered much of the stream bottom.

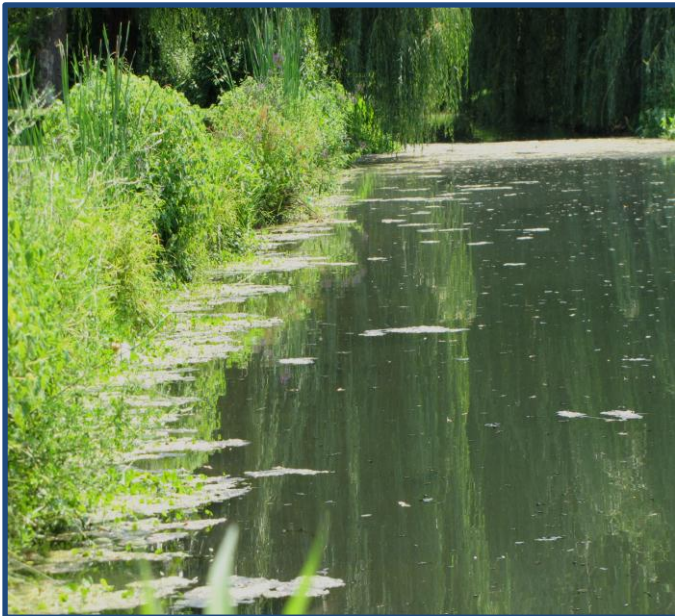
**Photo 3:** Upper Bay Street Pond in July of 2012 with mats of algae.

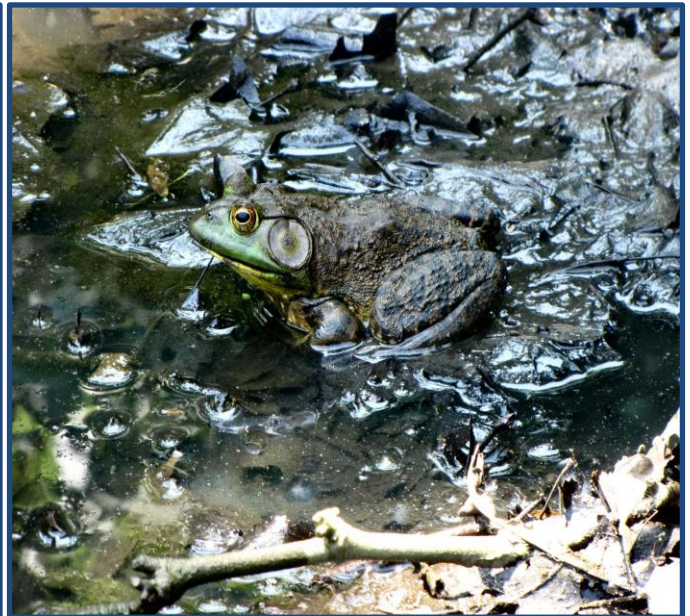
**Photo 4:** A Green Frog in Tanyard Branch east of TB4. The frog is sitting in a thick mat of algae. July, 2012

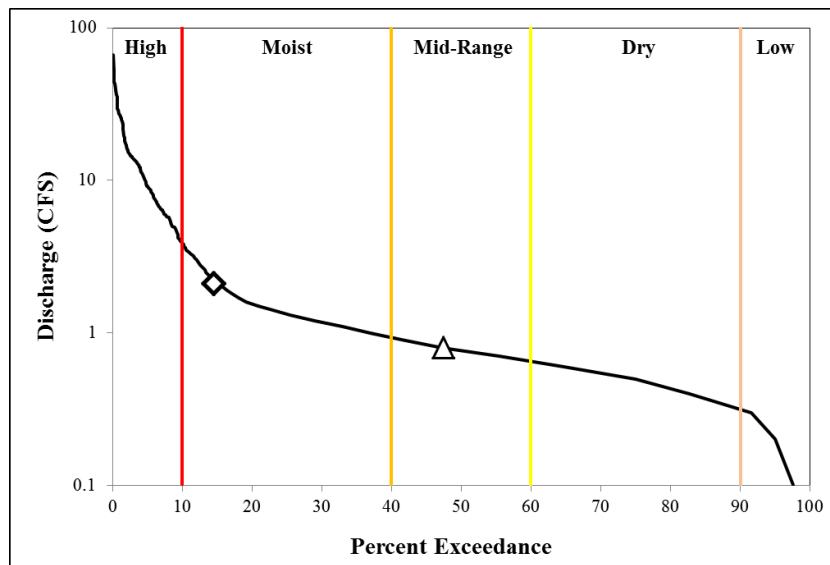
during a given period. The modeled period depicted in the graph is for 1300 days over the period 2006 to 2009. The graph displays that Tanyard Branch typically maintains relatively low streamflow, but increases dramatically during storm events. Storm events produce streamflows that are 40 to 80 times greater than low flow conditions.

**Figure 5. Flow-duration curve for modeled streamflow (discharge) in cubic feet per second (CFS) generated from HSPF model. High- storm events- streamflow at this volume occur <10% of the time, Moist- 10 to 40% exceedance- periods of excess rain (winter/spring). Mid-range- 40 to 60% transition to baseflow. Dry and Low- <60% exceedance Baseflow and drought condition, streamflow is usually greater than this except during droughts/late summer. Diamond identifies mean and triangle median.**

Although high streamflow storm events are not common, this is the period when most of the streamflow and loading occurs and would need to be managed. This can be seen in Table 4, where average daily nutrient loads calculated from samples taken at station TB5 are projected to annual loads for both low flows (majority of the year) and storm events (in this case streamflows that are <5% on flow duration curve, or 18 events during the year). TN loading is 3x higher during storm events than during low to normal streamflow conditions.

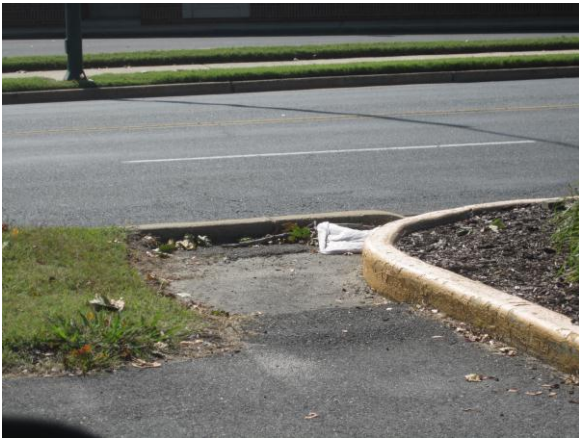
## TB2 Easton Plaza

**TB2-** Easton Plaza is another urban shopping center in Easton with no existing stormwater management. There are about 6 acres of impervious surfaces on this site including rooftops and parking lots. We recommend converting a minimal number of parking spaces in two key locations to construct bioretention facilities. In addition, we recommend converting the grassy medians into linear bioswales that run down each pavement edge (two in each green area), and to enhance drainage to the bioswales by constructing grated French drains perpendicular to the swales.

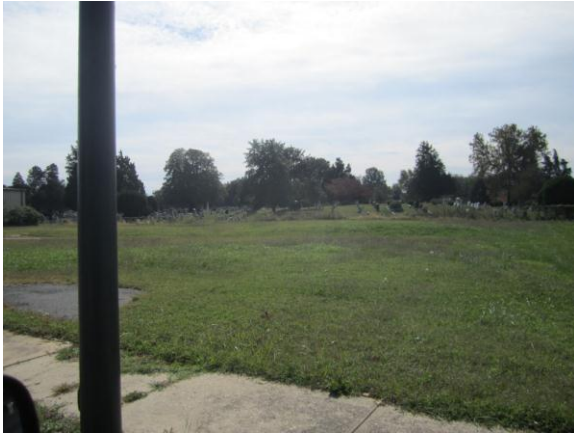
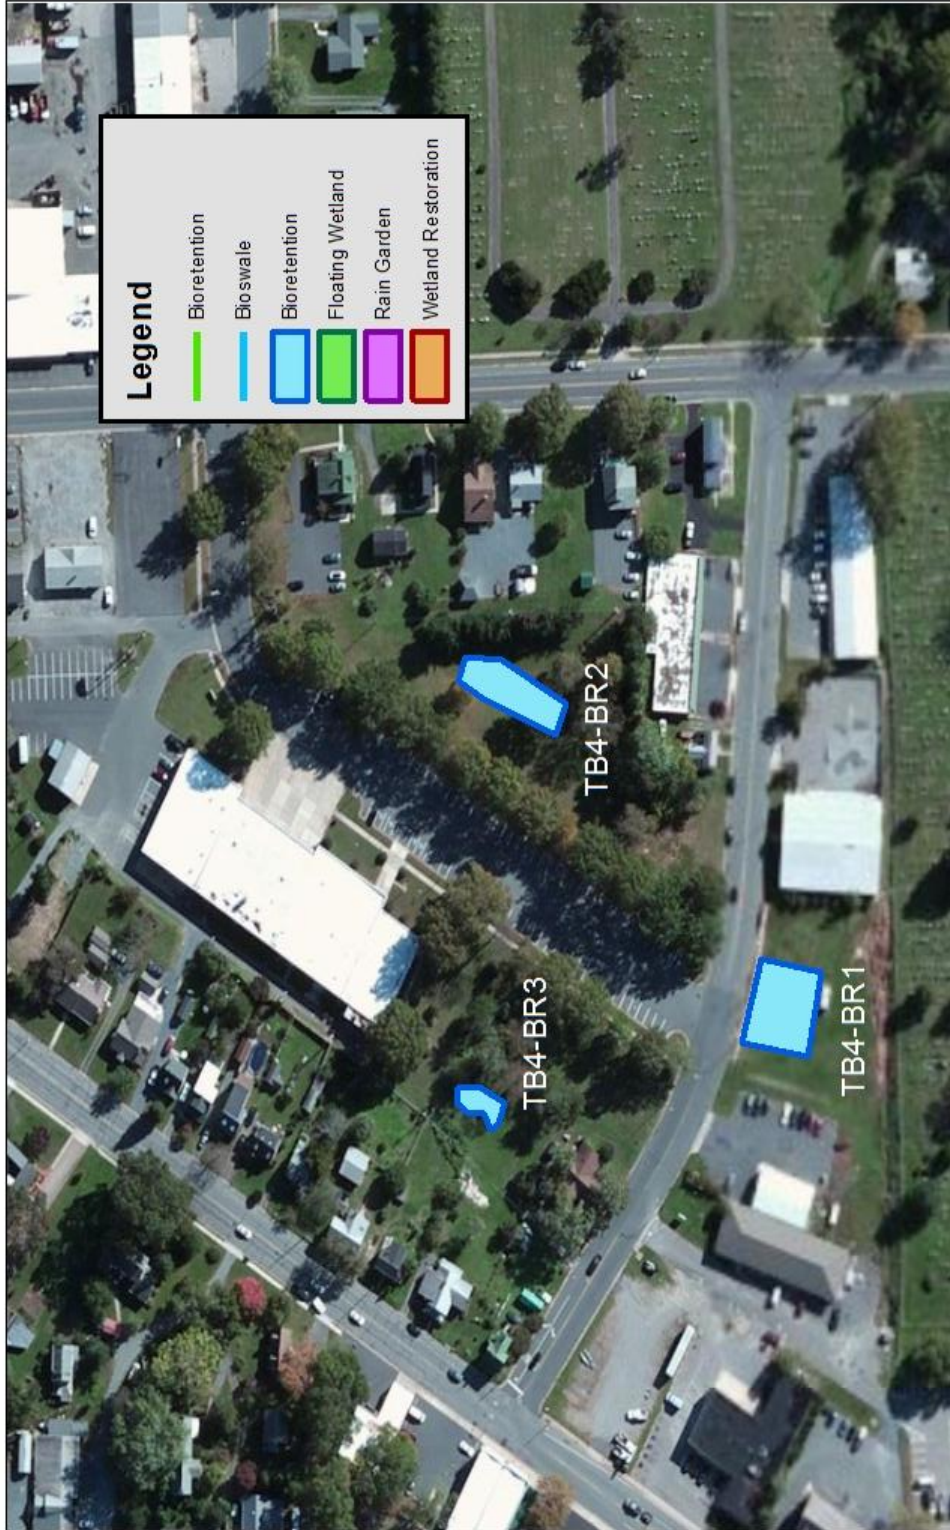
## TB4 Creamery Lane

**TB4:** This area is a mixed use commercial and residential neighborhood most of which was constructed without any stormwater management. There is a very high amount of impervious coverage in this area as well. We recommend a 5,100 sf regional bioretention cell in a vacant lot. In addition, we recommend a 3,600 sf bioretention facility on the open space across from the Easton Volunteer Fire Department (VFD) and a small facility just south of the Easton VFD.

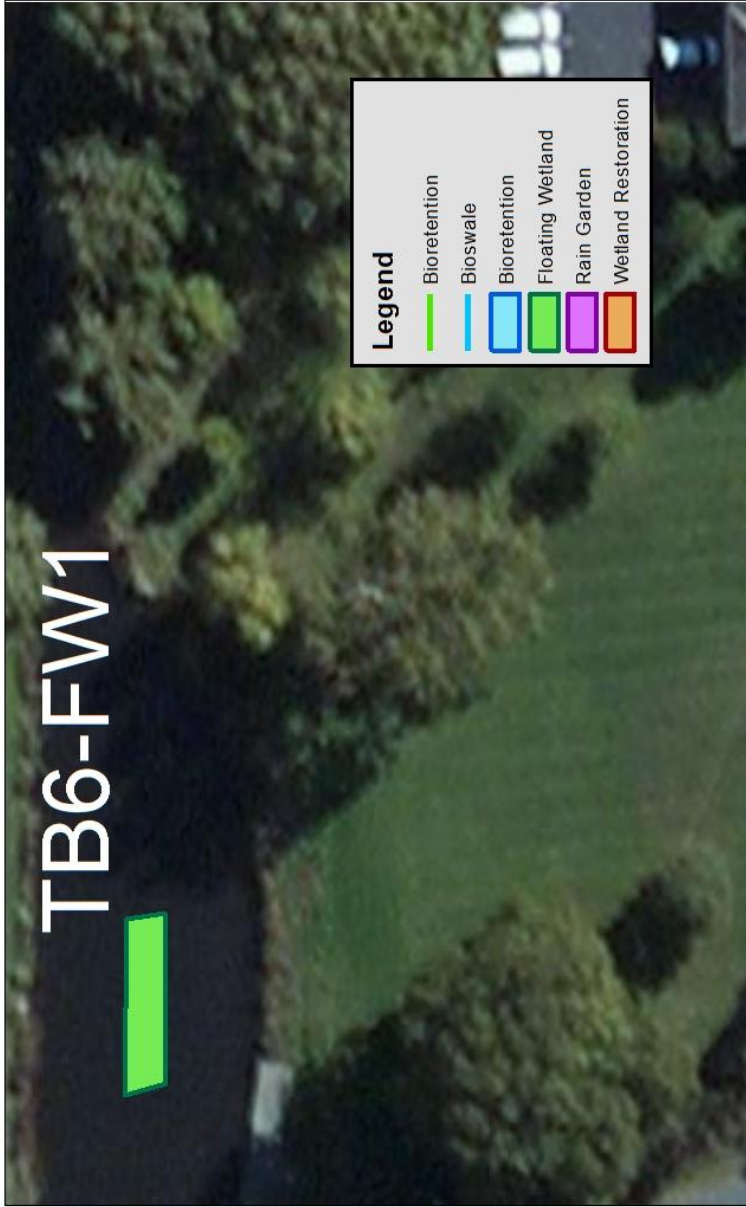
# TB6-FW1

**TB5:** Floating wetlands Bay Street Pond. This property is owned by The Waterfowl Festival. Ron Flohr, the president of the Waterfowl Festival, is receptive to the concept of floating wetlands and even the possibility that the Waterfowl Festival might be a financial supporter of such a project. Floating wetlands are the only practice recommended to be in-stream. They provide a cost-effective opportunity to reduce nutrient loads in Tanyard Branch and receiving waters. The high-end cost estimate includes three years of maintenance to the floating wetland. A source of electricity will need to be obtained for the compressor.

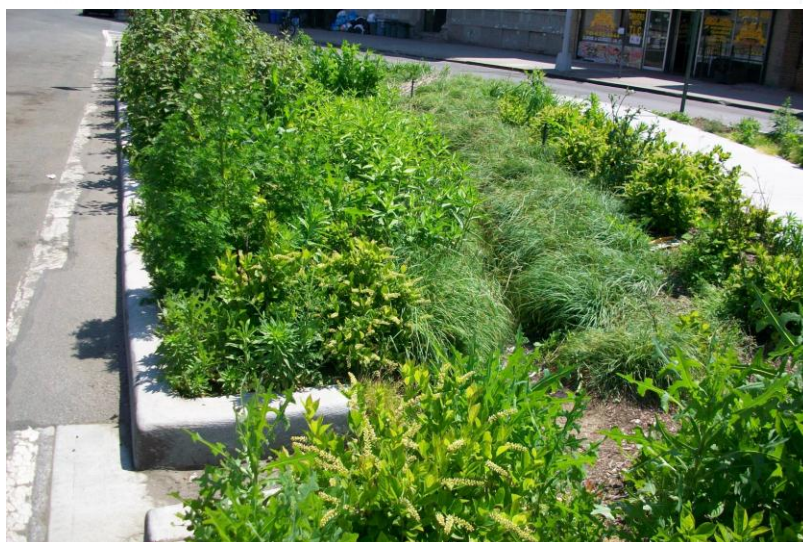
This is a photo of a typical bioswale with curb inlet from road.
